## Controlling the Hazard and Liability of Asbestos in Vermiculite Insulation

*Warnings for the Homeowner, Building Manager, Contractor and Real Estate Industry*

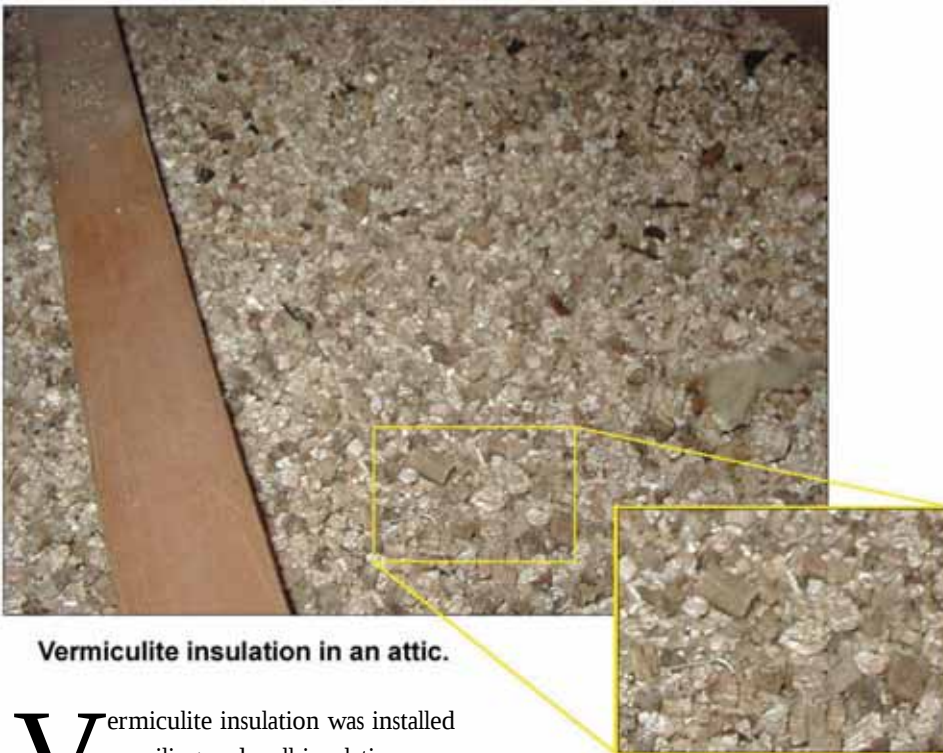
Vermiculite insulation in an attic.

Vermiculite insulation in loose form can be readily visually identified as a light weight, silvery grey or blonde, granular, layered material, with particle sizes of about 2 to 10 millimeters. If vermiculite is known to have been installed prior to 1990 visual identification should be adequate to confirm the material as asbestos-suspect.
